FIELD INVESTIGATION TEAM ACTIVITIES AT
UNCONTROLLED HAZARDOUS SUBSTANCES
FACILITIES — ZONE I

WORK PLAN OF
VALMONT SITE
PREPARED UNDER

TDD NO. F3-9012-26
EPA DSN PA-2245
FACILITY ID NO. PAD982363970
CONTRACT NO. 68-01-7346

HAZARDOUS SITE CONTROL DIVISION
U.S. ENVIRONMENTAL PROTECTION AGENCY

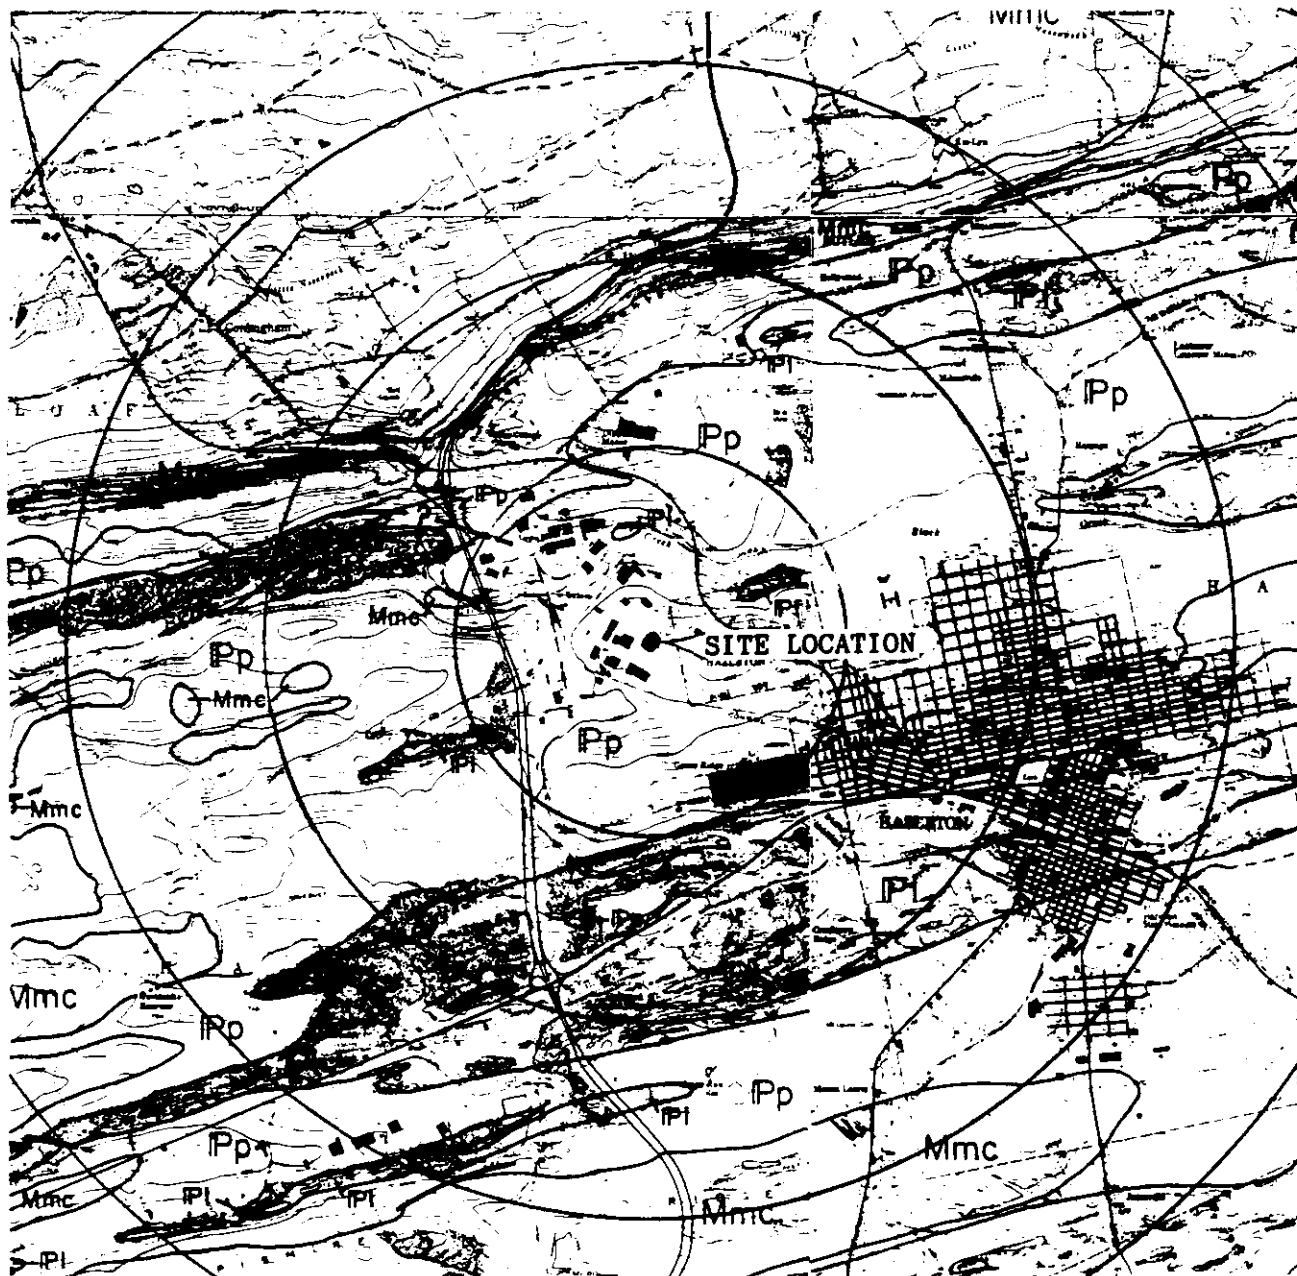
FIGURE 3-1

EXPLANATION

Pl - Llewellyn Formation;
Pp - Potsville Formation;
Mmc - Mauch Chunk Formation;

The site is underlain by the Pennsylvanian age Pottsville Formation. The formation consists of a gray conglomerate, conglomeratic sandstone, siltstone, sandstone, and some anthracite coal. The Pottsville Formation's thickness ranges from about 275 to more than 800 feet. The jointing and the faulting in this formation are important. The joints are moderately well formed, moderately to highly distributed, widely to moderately spaced in sandstone and close in shale, open, and vertical. Subsidence fractures may be encountered in connection with underground clay and coal mining.
